Behaviour of structural systems in residential buildings due to war damage caused by the Iraqi invasion

Keywords: abnormal loading (fire and shelling); damage assessment; infill walls; RC frame structures.

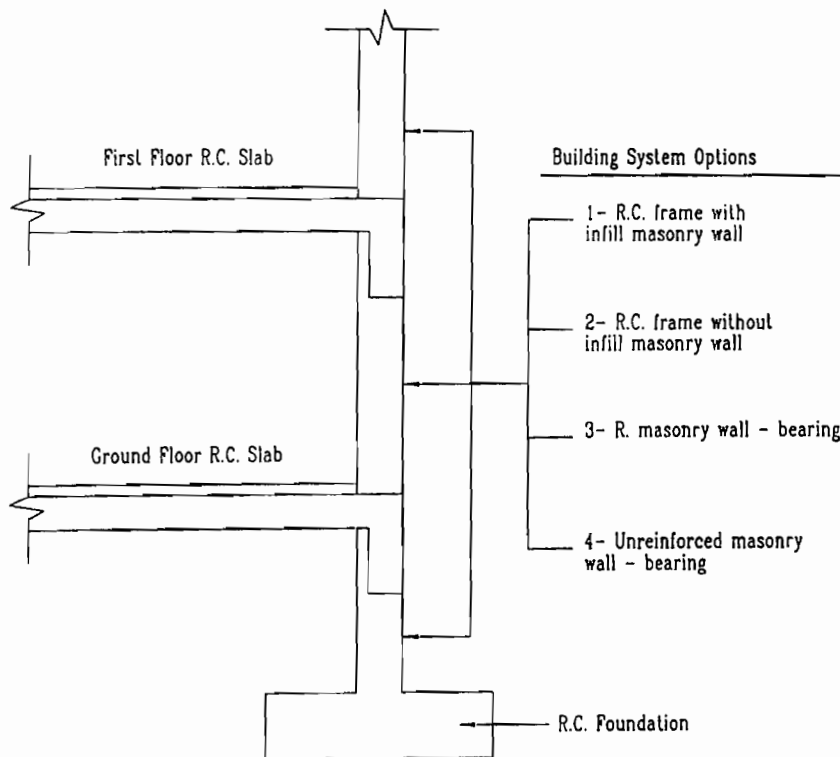
Fig. 1. The most widely used systems in Kuwait residential buildings.

Figure 1 summarizes the most widely used building systems in Kuwait. The predominant system is a reinforced concrete frame with infill concrete block walls and outside cladding, which may be stone or brick veneer. A detailed description of this system is given by Fereig and Horn (1990). The reason for such wide use of this system is the availability of materials such as sand, gravel and cement, and the availability of manpower with experience in such types of construction.
